Energy Conservation Measures
for the
Charles E. Shea Senior High School
Pawtucket, Rhode Island

A thermographic audit of a Pawtucket, Rhode Island high school is reported. Conducted with the aid of an infrared camera system, this thermographic study located heat losses not evident to the naked eye. Heat losses were documented and the thermograms analyzed to obtain complete knowledge of the location of all heat losses from the building complex. Each thermogram showed one or more types of heat loss together with the specific section of the building where it occurred. Priorities were assigned to various retrofit processes and a thermographic inspection conducted after retrofitting to confirm its efficacy. The study comprised an analysis and recommendations of heat loss and heating system appraisals plus an analysis of roof moisture inspection. Numerous thermograms illustrate the report. Results demonstrated thermographic inspection to be a highly effective analytical technique for appraising the relative thermal efficiency of buildings. Based on evidence from the thermographic energy audit, low, moderate, and high cost options were prepared for reducing heating costs. The importance

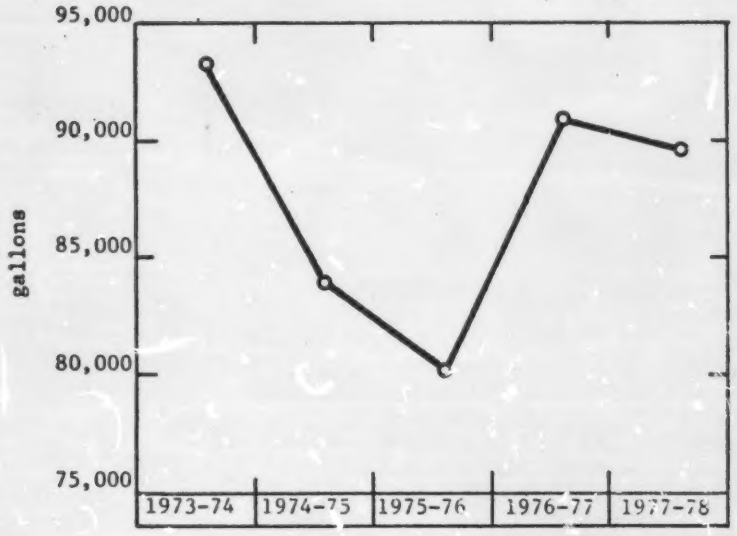
Figure 1. Fuel Oil Consumption, 1973-78

Although attempts have been made at Shea High School to reduce the volume of the air changes and to achieve temperature setbacks, Figure 1 shows that a reduction in consumption of only 1 percent has been achieved since July 1976. The difficulty encountered in further reducing consumption is undoubtedly due to the problem of controlling the temperature, a problem caused in part by the malfunctioning of the unit ventilators.

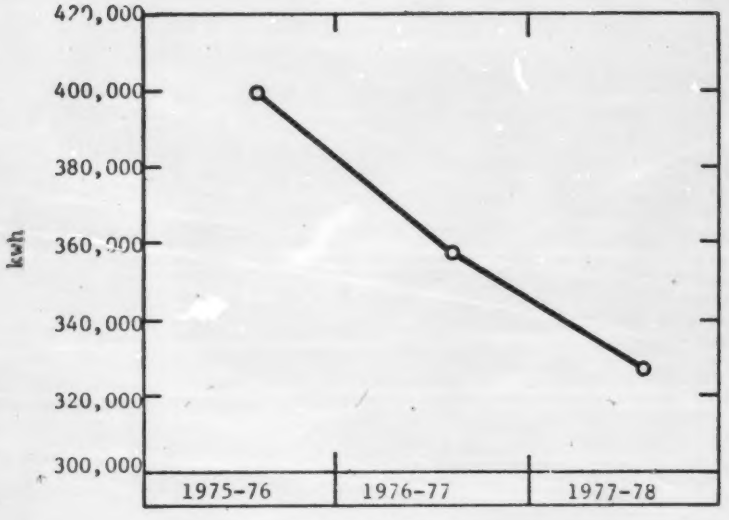
Figure 2. Electric Consumption, 1975-78

Figure 2 shows a steady decrease in electrical consumption at the Shea High School during the 1975-78 period. This 22 percent decrease has resulted in a 21 percent decrease in cost.

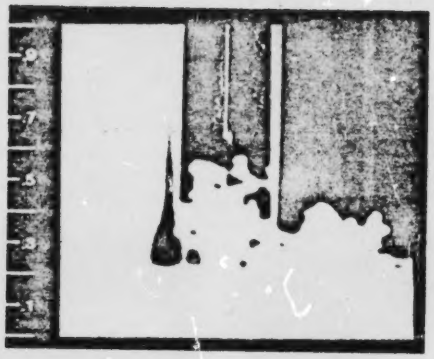
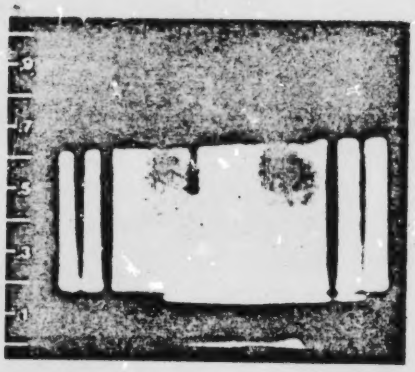
1

1.-2. Around sill of double-hung window in science room

The thermographic inspection clearly indicated that the air leakage around the original windows is not excessive. Further quantitative analysis showed that the total heat loss through the newer windows is only slightly less than that through the original windows, resulting in an abnormally long payback period.

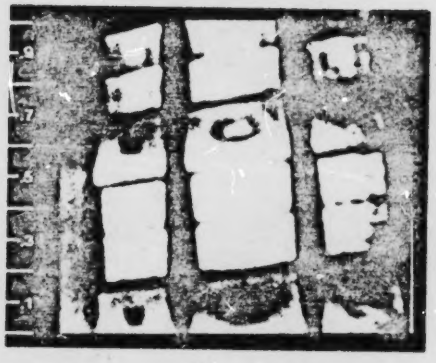
3

3. Around rails of third floor windows

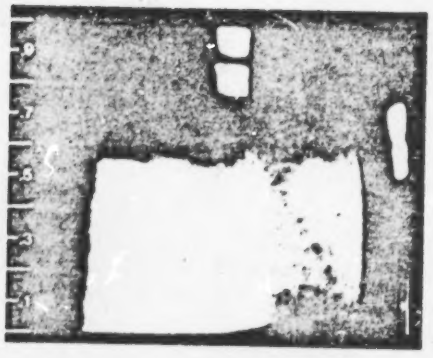
Thermogram 10 shows excess heat escaping from the vent in the swimming pool area after normal school hours. The temperature in the pool area was in excess of 80°F at the time of the inspection.

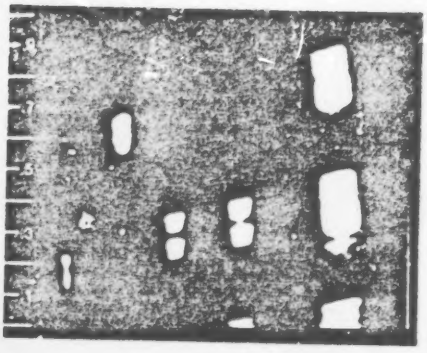
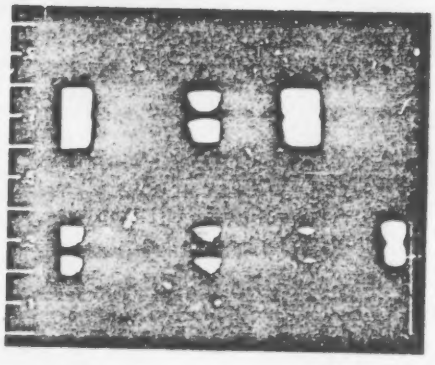
20

20.-21. Excess heat loss from overheated hallways after normal school hours

During the thermographic inspection, the temperatures in the corridors were above 70°F at 6 PM. The radiator in the stairwell was heating when no classes were in session. As is the case in the classrooms the radiators in the hallways cannot be shut down either because the valves are missing or because the valves were never installed in the first place.
